Anacostia Trash TMDL-Related Baseline Conditions Monitoring (June 2008 - July 2009)

Metropolitan Washington Council of Governments,
Department of Environmental Programs

Montgomery County
Department of Environmental Protection
and
Prince George's County
Department of Environmental Resources

October 23, 2009

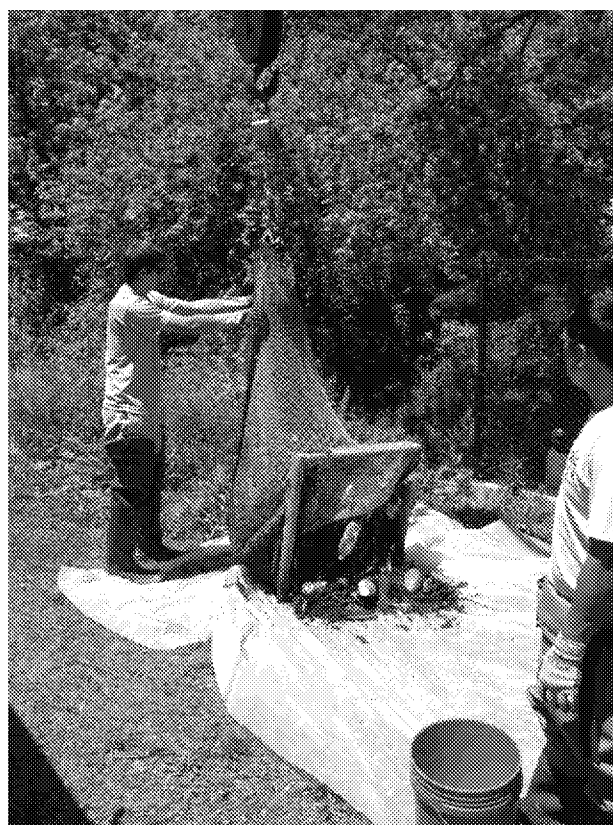
Figure 76 - Lower Beaverdam Creek - COG Staff Surveying Fresh Creek Trashtrap Net Content

Two Fresh Creek Netting Trashtrap® systems, both of which are located in Prince George's County, were surveyed. The 659-acre Ray Road system, which is located in the Takoma Branch, a tributary to the Sligo Creek subwatershed, employs five nets with 0.5-inch openings. The 40.8-acre Flagstaff Street system, which is located in the Lower Beaverdam Creek subwatershed (Figure 76), employs four nets with 0.5-inch openings. It should be noted that due to PGDER maintenance subcontractor time limitations and project budget constraints, only three of the five nets at the Ray Road site and one of the four nets at the Flagstaff Street site were surveyed. For additional Fresh Creek Netting Trashtrap® system, the reader is referred to Appendix 6.

Due to severe structural damage caused by a series of high intensity rainfall events, the Ray Road netting system was again taken off-line in early June 2009. No timetable has been set by PGDER for repairing/upgrading the Ray Road system.

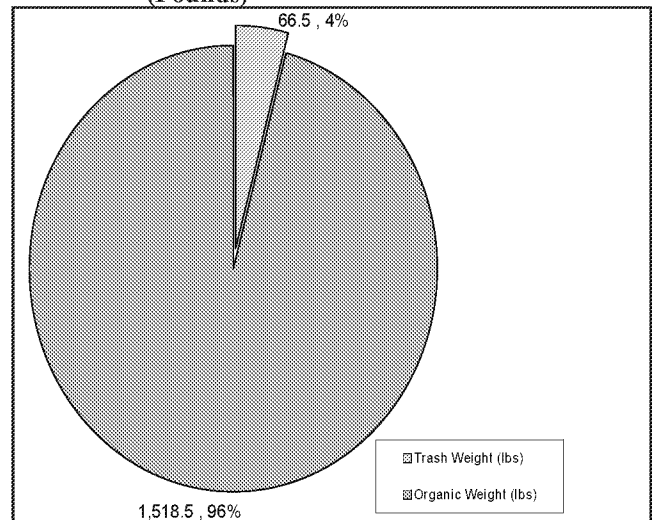
Figure 80 - Flagstaff Street (Lower Beaverdam Creek) - Trash and Organic Debris Weights (Pounds)
